# Manhole Inspection Summary

Manhole # S55M\_\_017MH

Insp Date: **6/6/08 9:08 AM**

**Location** Address: **913 bylis st**

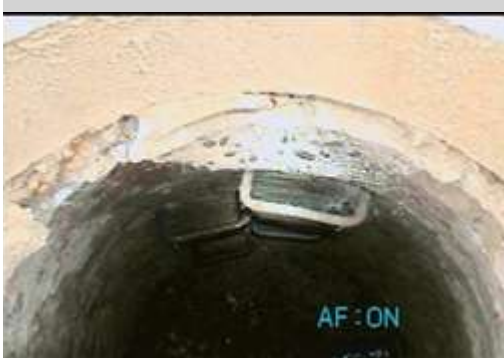
Defect 2

Condition: ☐ Sound ☐ Cracked ☐ Root Intrusion ☐ Loose Brick ☒ **Deteriorated**

Count: **4** Missing: **0** ☒ **Corroded**

corbel deteriorated corroded steps

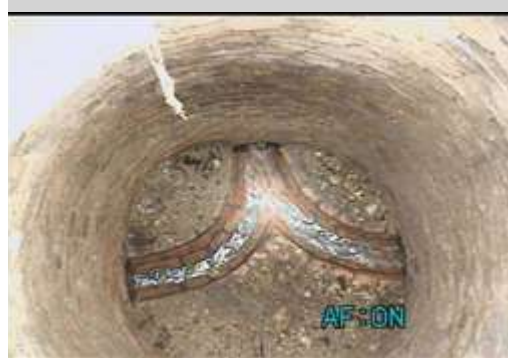
Defect 1

Condition: ☐ Sound ☐ Cracked ☐ Root Intrusion ☐ Deteriorated ☐ Leaks ☒ **Debris**

bench debris

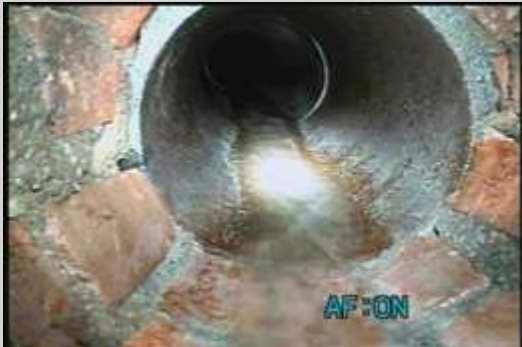
12 O'Clock Outflow

8 in. Circular Gravity Sewer  
Pipe Out @ 12 O'Clock

Invert Depth: **9.80** (ft.) Flow Characteristics: **Fast**

Deposits: ☒ None ☐ Mud ☐ Sludge ☐ Debris ☐ Grease

Infiltration: **None** Pipe Seal Cond: **Unknown**

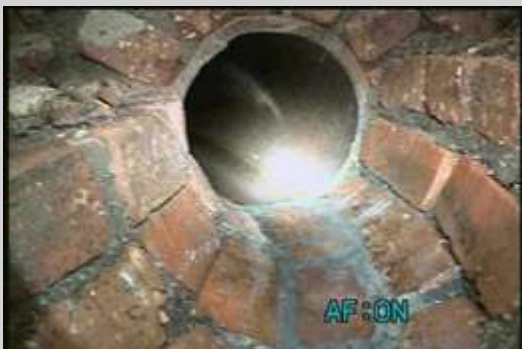
3 O'Clock Inflow

8 in. Circular Gravity Sewer  
Pipe In @ 3 O'Clock

Invert Depth: **9.50** (ft.) Flow Characteristics: **Slow**

Deposits: ☒ None ☐ Mud ☐ Sludge ☐ Debris ☐ Grease

Infiltration: **None** Pipe Seal Cond: **Unknown**

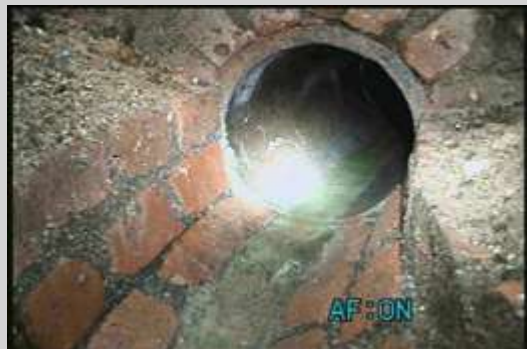
9 O'Clock Inflow

Pipe In @ 9 O'Clock

Invert Depth: **9.50** (ft.) Flow Characteristics: **Fast**

Deposits: ☒ None ☐ Mud ☐ Sludge ☐ Debris ☐ Grease

Infiltration: **None** Pipe Seal Cond: **Unknown**
